April 28, 2017 Sandra Bodamer King Water Co Po BOX 2243 Oak Harbor, WA 98277	West Beach Rd ID #17970	
	County:	Island
	System Type:	Group A Community
	Operating Permit Color:	Green
	Surveyor:	Virpi Salo-Zieman
	Inspection Date:	April 25, 2017

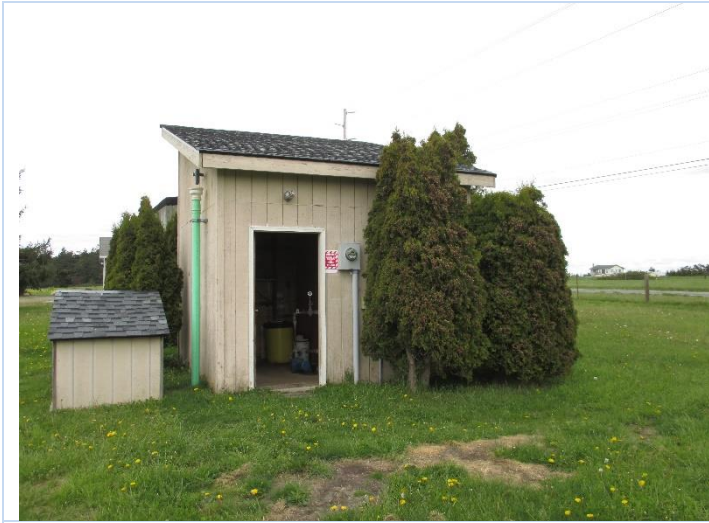
Pump house (reservoir behind)

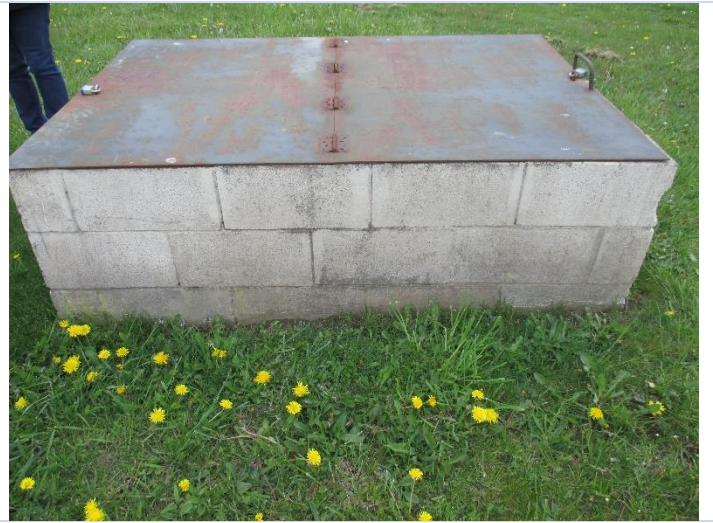
Well enclosure

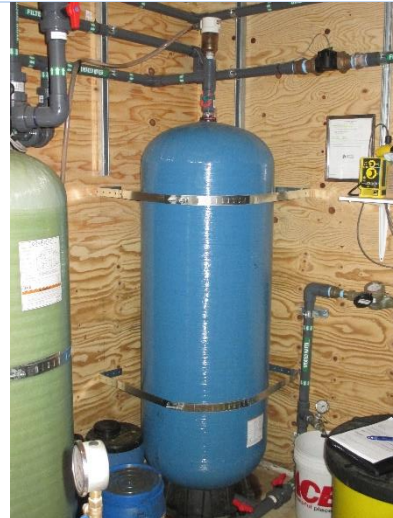
Contact tank (chem feed on the right)

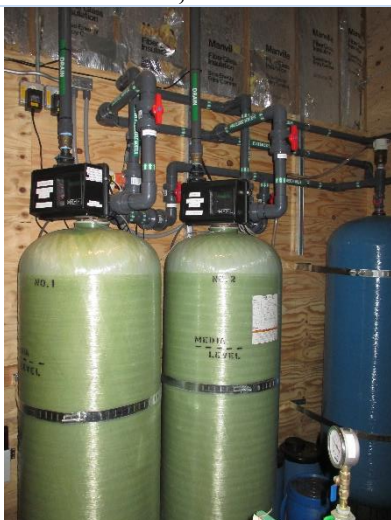
Twin 21" D filters with individual control valves

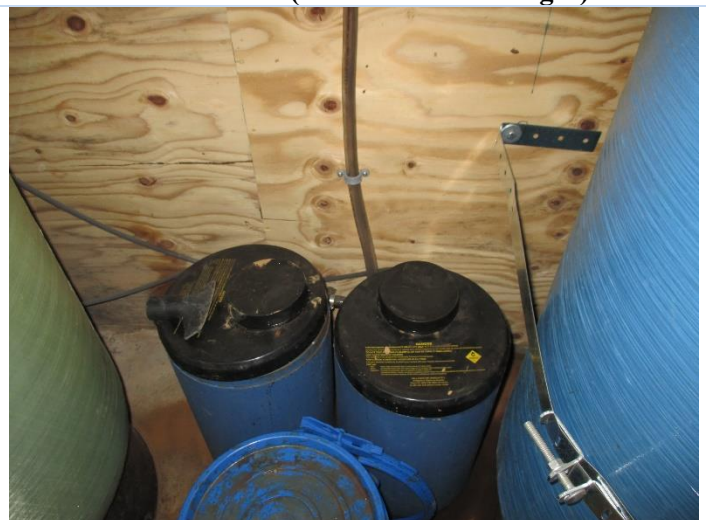
Pot Perm saturators for filter regeneration

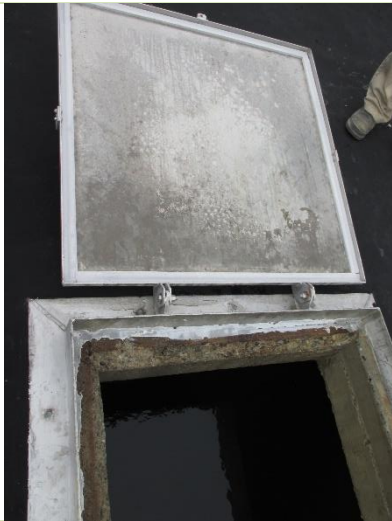
Reservoir hatch

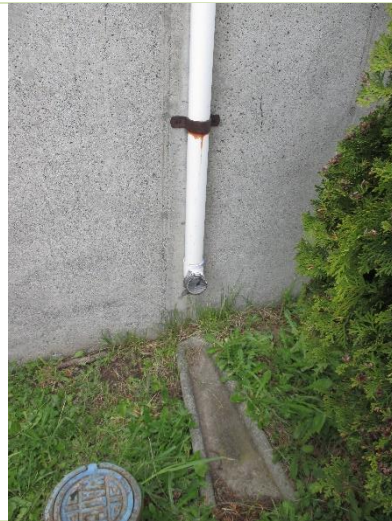
Reservoir overflow

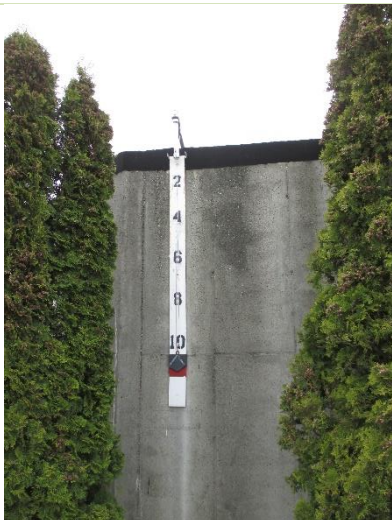
Reservoir level gauge

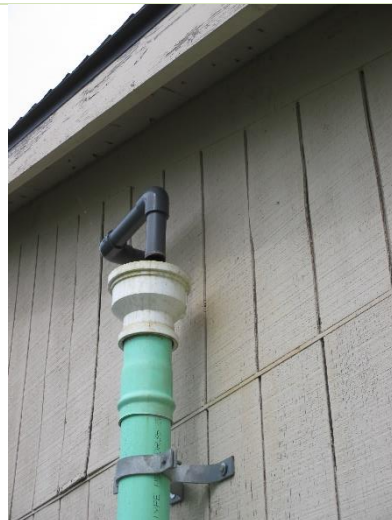
Backwash discharge

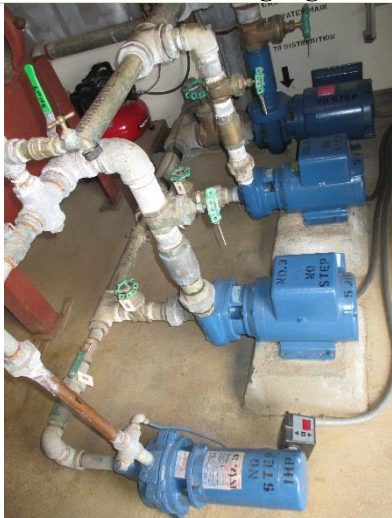
Pump station

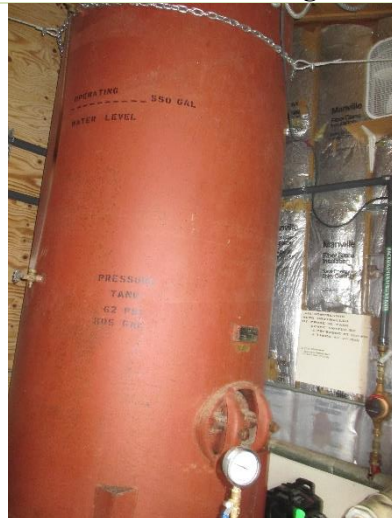
There is a pressure relief valve on the side of the hydropneumatic tank.

HPN tank, PRV on the back side

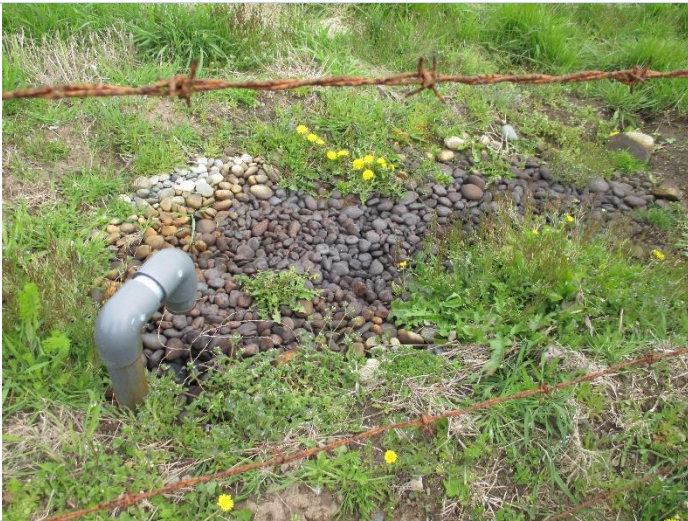
Backwash discharge

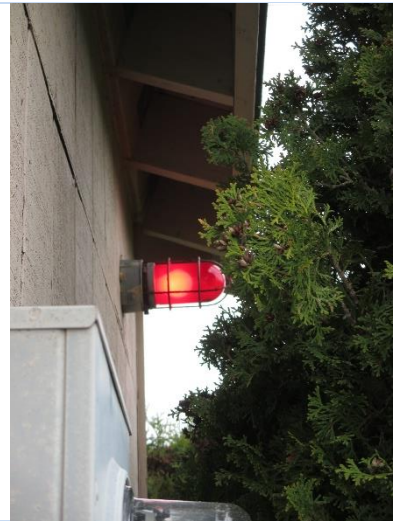
There is a red light outside the pump house that will lit if reservoir level is low.

Red light for low reservoir level

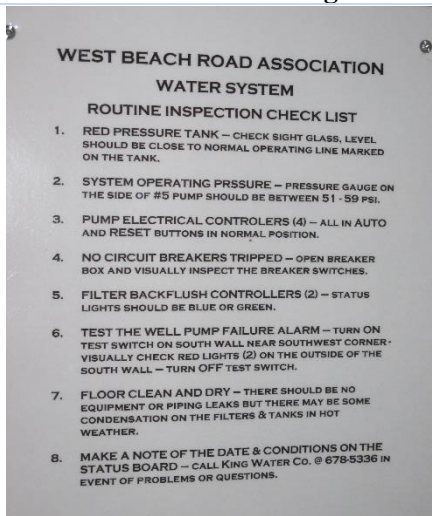
Laminated checklists in the pump house

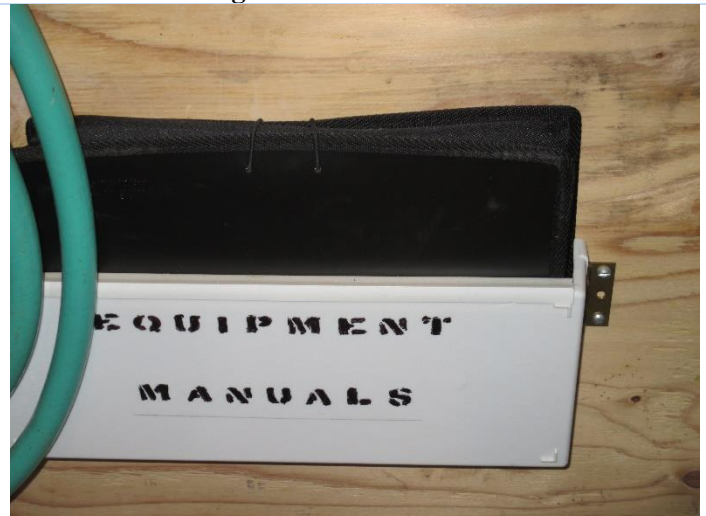
Equipment manuals in the pump house

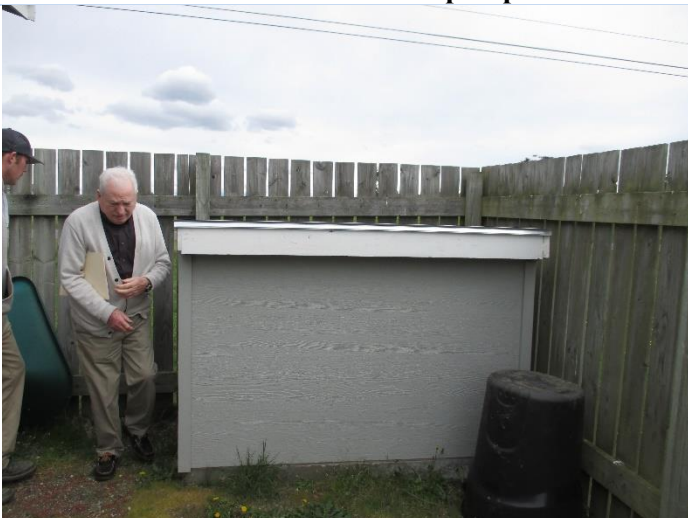
New housing for the generator

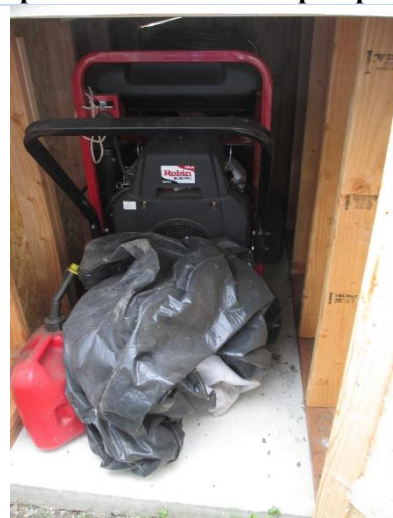
Gasoline powered portable generator
